# Extraction of left ventricular pacing lead inserted via the left subclavian artery

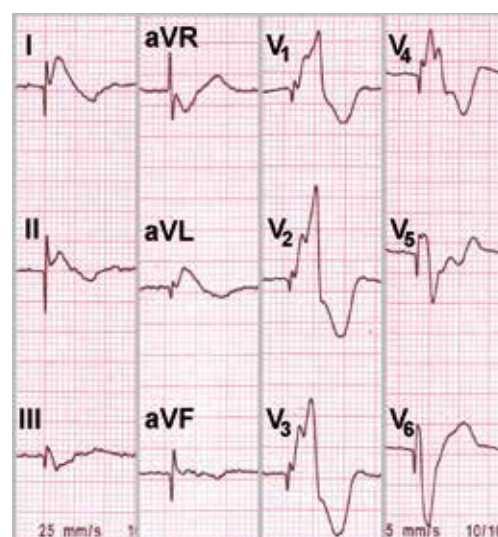
**FIGURE 1** A – electrocardiographic recording; pace, 25 mm/s; feature, 10 mm/mV

A 90-year-old woman was admitted to the hospital for lead removal. Six weeks before admission, she had been implanted a ventricular pacing system owing to symptomatic, second-degree atrioventricular block. The ventricular lead was implanted by the vessel puncture. A severe condition of the patient during the procedure with recurring asystoles and blood pressure drops was most probably the reason why the puncture of the left subclavian artery and implantation of the lead into the left ventricle was not diagnosed. During postoperative period, normal stimulation parameters were recorded and right bundle branch block, typical of the left ventricular pacing (FIGURE 1A), was seen on electrocardiogram. On chest X-ray, the image of the lead passing along the left subclavian artery, arch-like up over the pleural cupula and along the left edge of the vertebral column, was not carefully evaluated (FIGURE 1B).

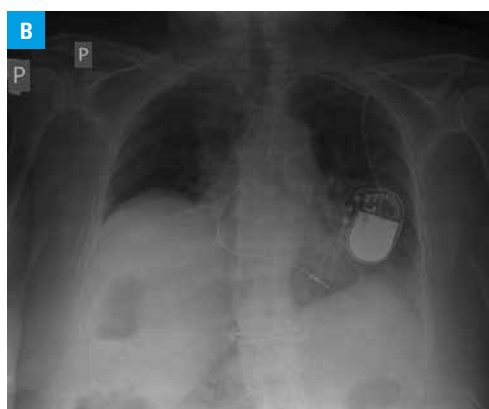
**FIGURE 1** **B** – thoracic X-ray imaging; posterior-anterior projection;  
**C** – transthoracic echocardiography; parasternal projection; longitudinal axis;  
**D** – computed tomography; reconstruction;  
**E** – left subclavian vein venography
