Symptomatic segmental pulmonary thromboembolism secondary to acrylic embolization after vertebroplasty

Marta Rybak-Bąk¹, Monika Wolnicka¹, Agata Ziętek², Kinga Kiszka²

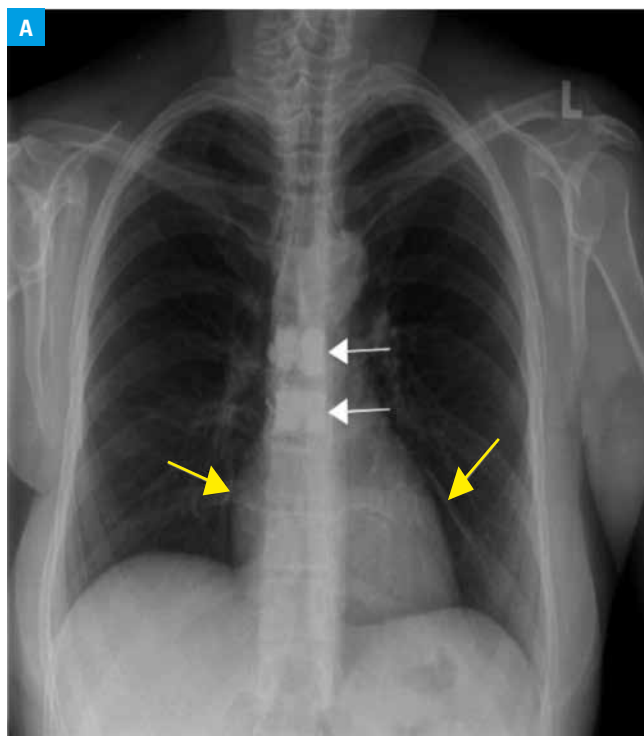
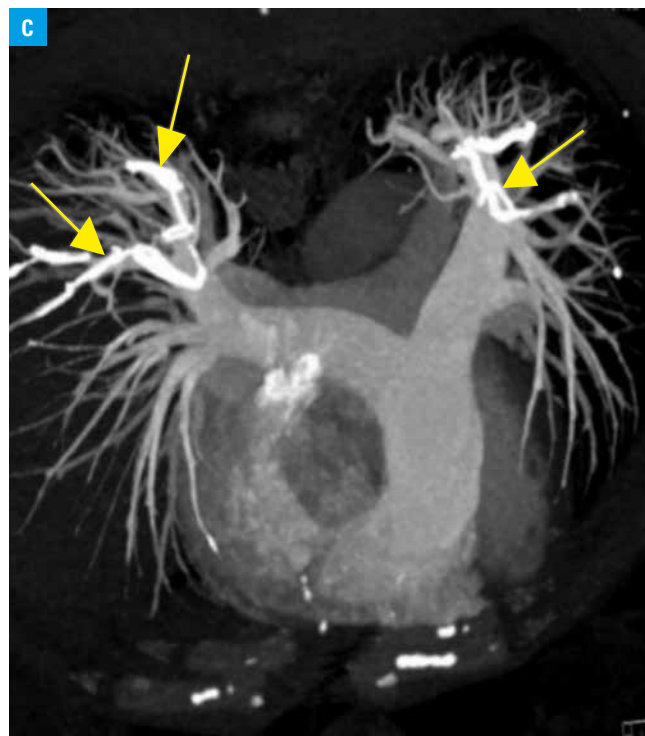
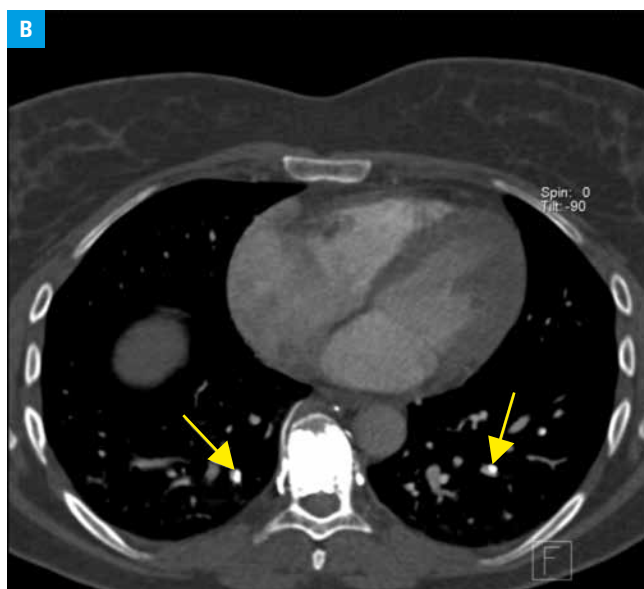
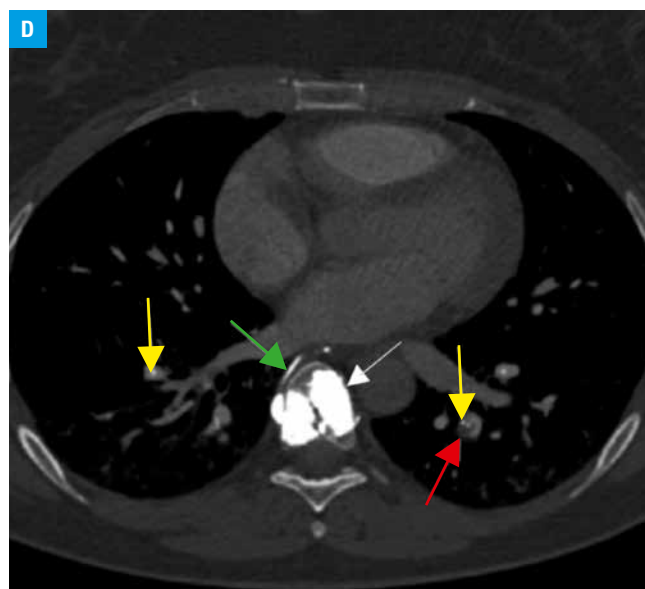
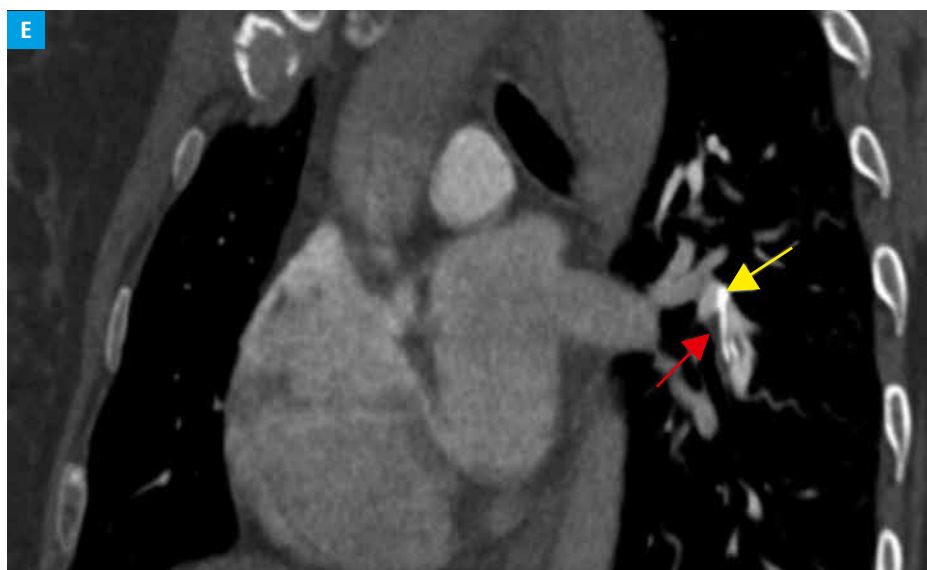
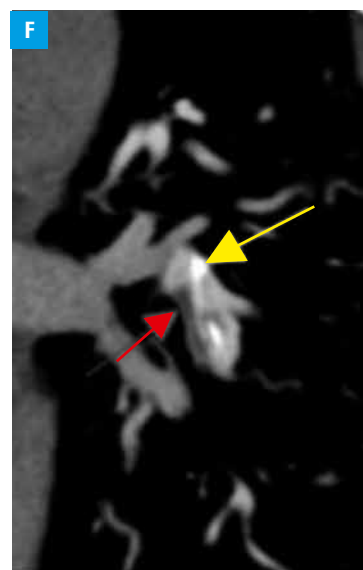
FIGURE 1 **A** – posteroanterior chest radiograph with high-density linear opacities outlining pulmonary vessels into the lower lobes related to cement emboli (yellow arrow); kyphoplasty cement in the thoracic vertebral bodies Th7 and Th8 (white arrow); a computed tomographic pulmonary angiogram with hyperdense material filling bilaterally distal; **B** – pulmonary arteries displaying the same density as the kyphoplasty cement (yellow arrow); **C** – volume rendering technique shows high-density material within segmental branches of the pulmonary arteries to the lower lobes related to acrylic pulmonary embolism after vertebroplasty (yellow arrow); **D** – computed tomographic pulmonary angiogram (CTPA) shows kyphoplasty cement pulmonary embolism (yellow arrow) due to extravasation of cement into the paravertebral veins (green arrow) surrounding the treated vertebrae (white arrow) and appositional thrombus formation in the segmental pulmonary branch (red arrow); **EF** – CTPA reveals in situ thrombosis (red arrow) in the 10th segment of the left pulmonary artery at the site of prior cement embolus (yellow arrow)

reveal any abnormalities. A chest radiograph revealed high-density linear opacities outlining pulmonary vessels into the lower lobes (FIGURE 1A). A computed tomographic pulmonary angiogram (CTPA) (FIGURE 1BC) confirmed extravasation of hyperdense material of the same density as the vertebroplasty cement filling bilateral proximal and distal pulmonary arteries (FIGURE 1D). A thrombus formed in the 10th segmental left pulmonary artery was detected (FIGURE 1DEF) at the site of prior cement embolus. An ultrasound excluded deep vein thrombosis. Initially, subcutaneous nadroparin (8550 IU AXa twice a day) followed by long-term oral acenocoumarol therapy was administered. Two-year follow-up shows satisfactory general condition with mild exertional dyspnea and persistent signs of cement embolization on the chest radiograph. Pulmonary hypertension and thrombophilia were excluded.
