Scisło P, Rdzanek A, Pietrasik A, et al. The function of the heart after successful transcatheter mitral valve repair due to severe functional regurgitation. Pol Arch Intern Med. 2021; 131: 686-692. doi:10.20452/pamw.16000

Figure S1. Pre- and post-procedural echocardiographic evaluation.

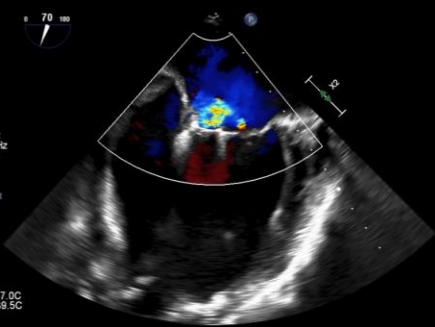
TEE3D CD, Commissural view

Before ETE-TMVR

After ETE-TMVR
